Valley Rural Utility Company

Water Utility Improvements Asset Management Plan
April 2025 Update

CEI Project #W23088

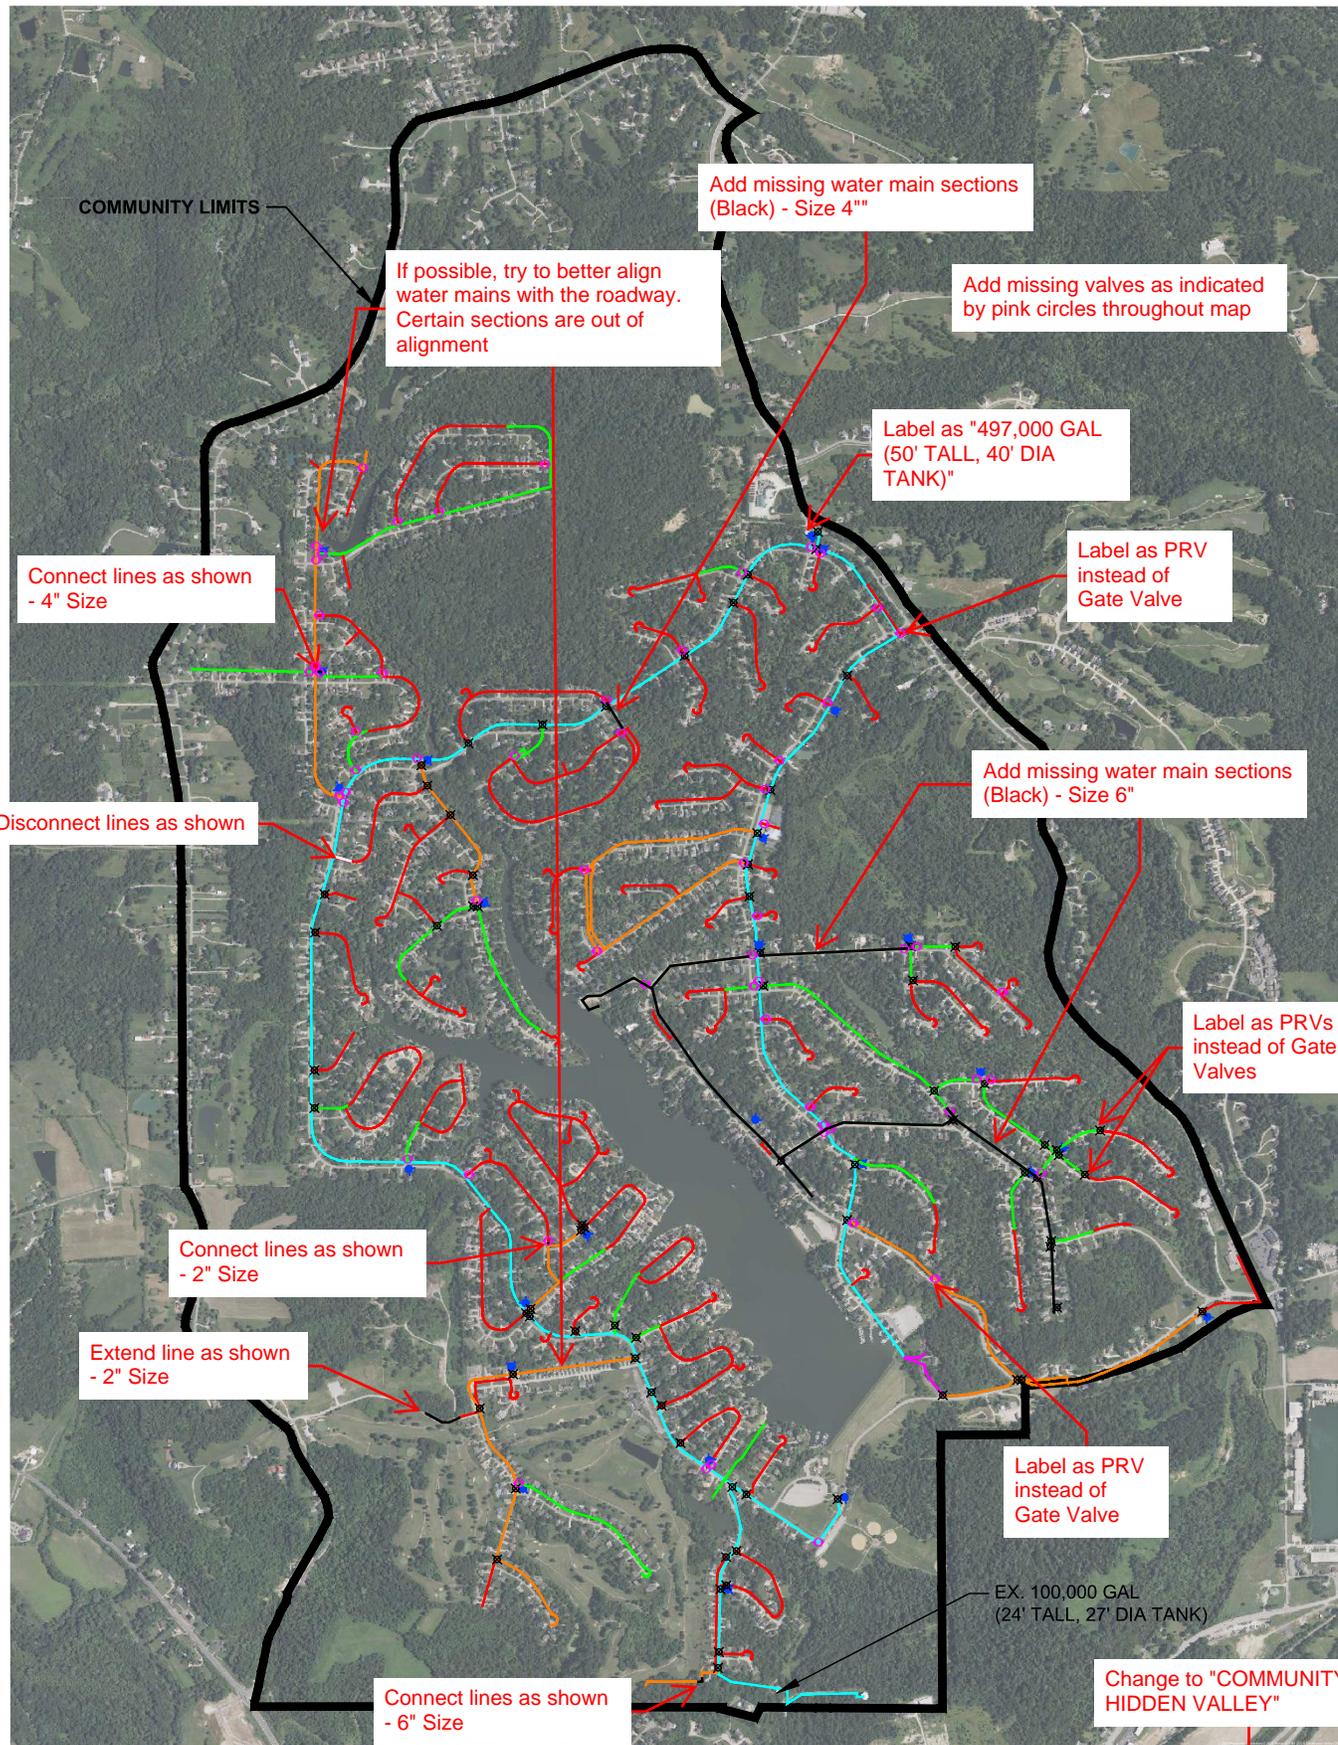
The majority of the water distribution system, which serves approximately 1,942 connections in the Hidden Valley, was installed between 1971 and 1979 and is comprised of polyvinyl chloride (PVC) pipe. **Figure 5-1** depicts the existing distribution system within the Utility service area.

Small sections of the distribution system have been replaced since initial installation, but specific quantities and locations are unknown. Three (3) new fire hydrants were installed in 2002. Additionally, the Utility regularly replaces customer meters and performs maintenance on the tanks.

Aging water mains in the system increase the chance of a water main leak and/or break. Leaks and breaks in the system can create a dangerously low system pressure providing potential for contaminants to enter the pipe network. The pipe network that makes up the distribution system is detailed in **Figure 5-1**.

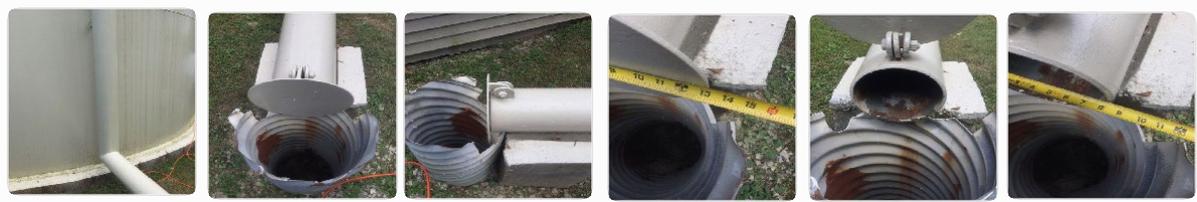
Photo of Flapper

Water Level Indicator Type(s)	Not Available
Condition of Water Level Indicator(s)	N/A
Condition of Overflow	Good
Light corrosion inside the pipe	
Does Overflow Extend to Ground/Accessible?	Compliant
Does Overflow Flapper Seal?	Compliant

Overflow Diameter 8"

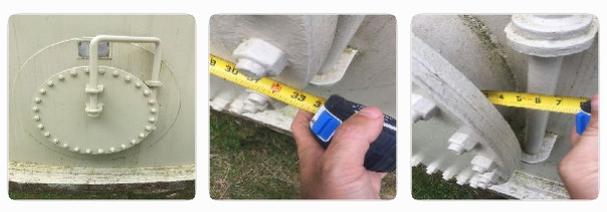
Photo of Side Manway Access Hatch

Condition of Sidewall Protective Coating (SSPC Rating)	9
Condition of Side Manway Access Hatch	Good

Size of Manway Access Hatch 24"

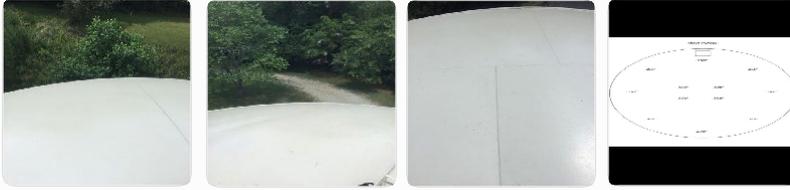
Photo of Roof Plates

Condition of Roof Plates

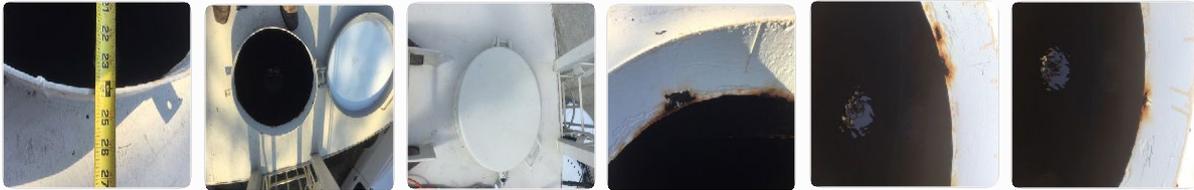
Photo of Water Access Hatch

Condition of Water Access Hatch

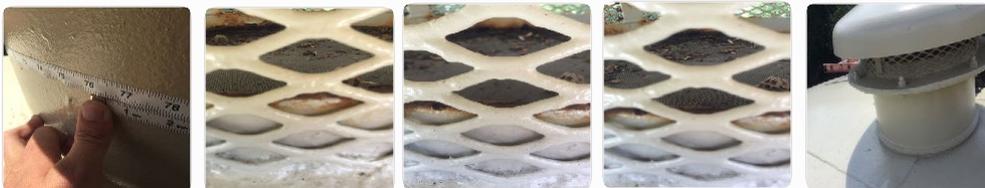
Photo of Roof Vent

Mushroom Shape

Condition of Roof Vent
