VALLEY RURAL UTILITY COMPANY
 DEARBORN COUNTY, INDIANA
 PRELIMINARY ENGINEERING REPORT
 EXISTING FACILITIES
 FIGURE ES-1

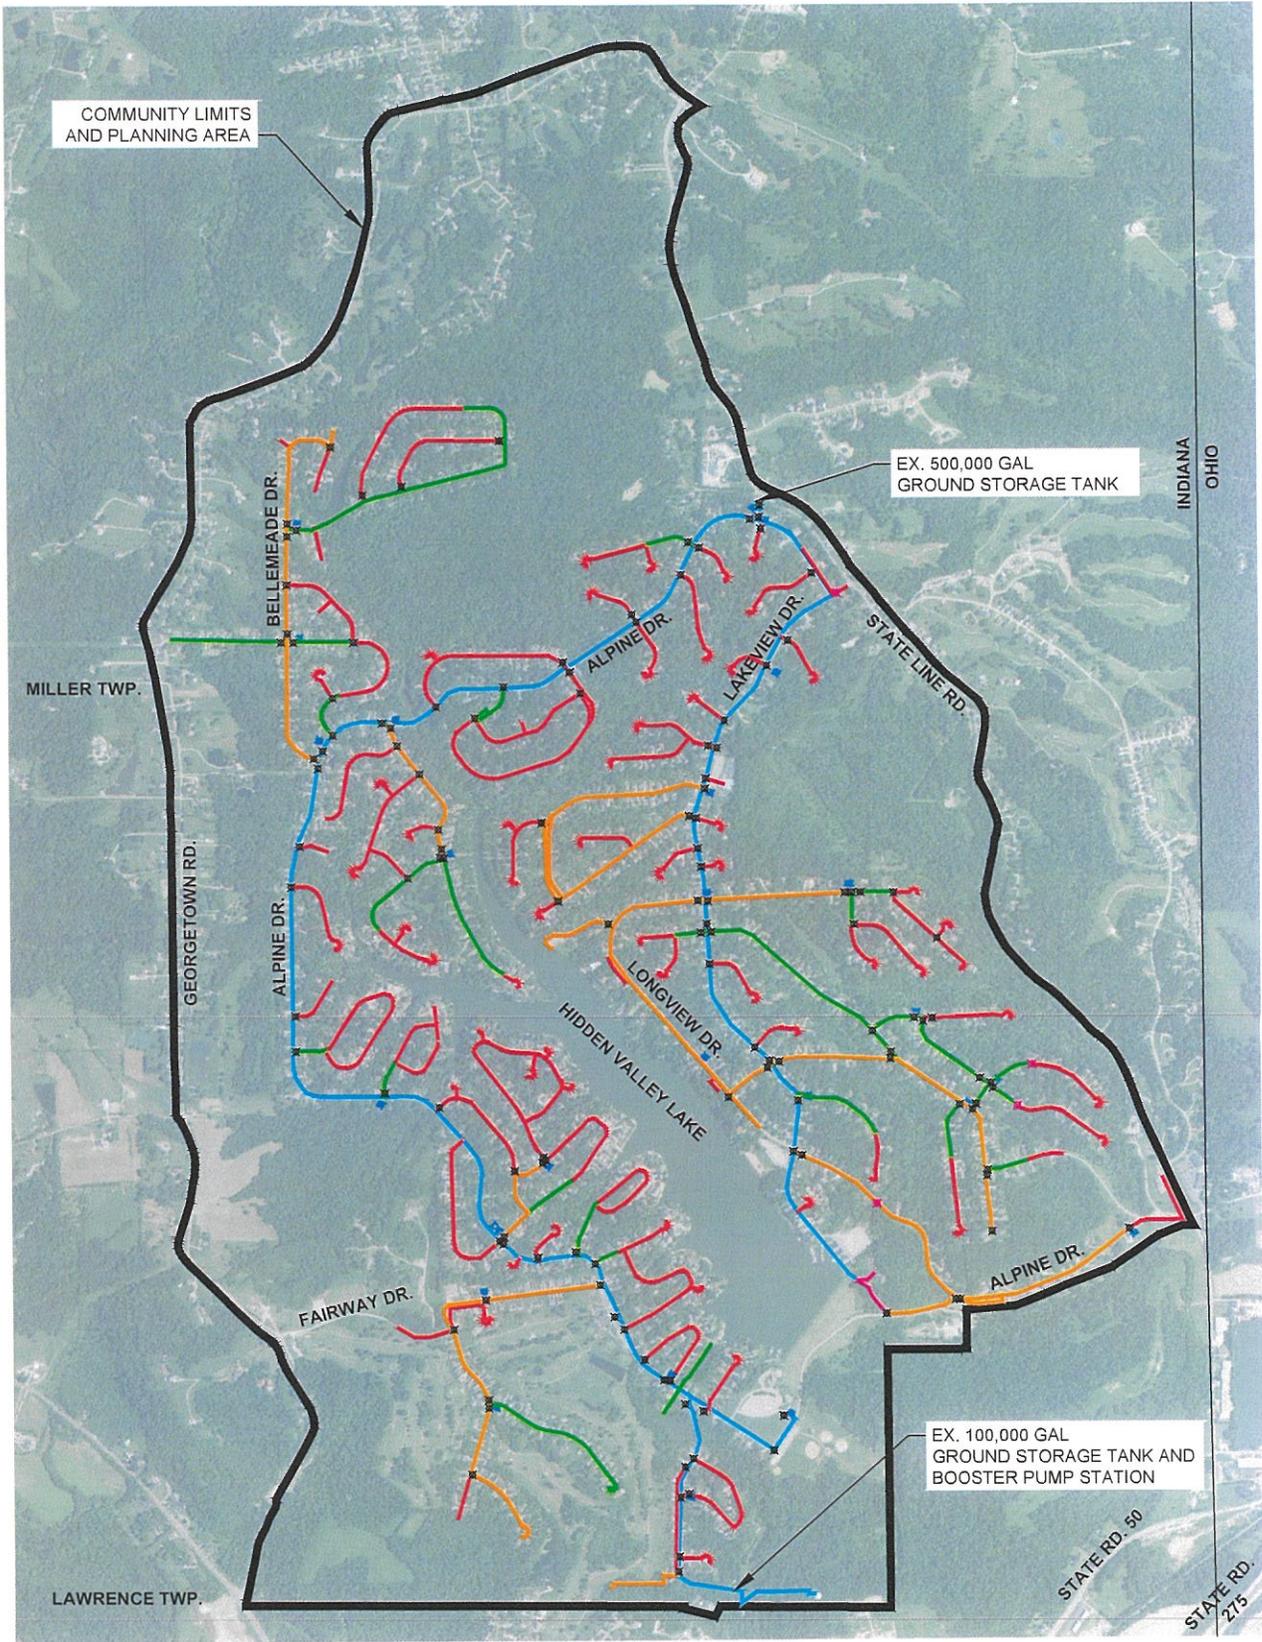
- EX. WATER MAIN 1"
- EX. WATER MAIN 2"
- EX. WATER MAIN 4"
- EX. WATER MAIN 6"
- EX. WATER MAIN 8"
- EX. WATER HYDRANTS
- ✕ EX. GATE VALVES
- ✱ EX. PRV
